A successful case of water cut-off by ground freezing in the excavation of the shaft DST-1

ABSTRACT: The construction of the shaft DST-1, 14 m diameter, 65 m deep of the Dugway Storage Tunnel Project (Cleveland), was completed following significant obstacles in the shaft excavation process. After applying different soil treatments (dewatering, jet grouting, permeation grouting) ground freezing was selected as a technically appropriate alternative. Since steel liner plates and ribs were installed in the initial excavation phase, consideration was given to the frost pressures generated by the freezing process. This paper describes the field and laboratory testing as well as the engineering analysis required for freezing to permit excavation below the existing liner plates and into the underlying bedrock. The existing liner plates and ribs were instrumented to assess the effects of the freezing and compare additional forces with those evaluated during the ground freezing design.

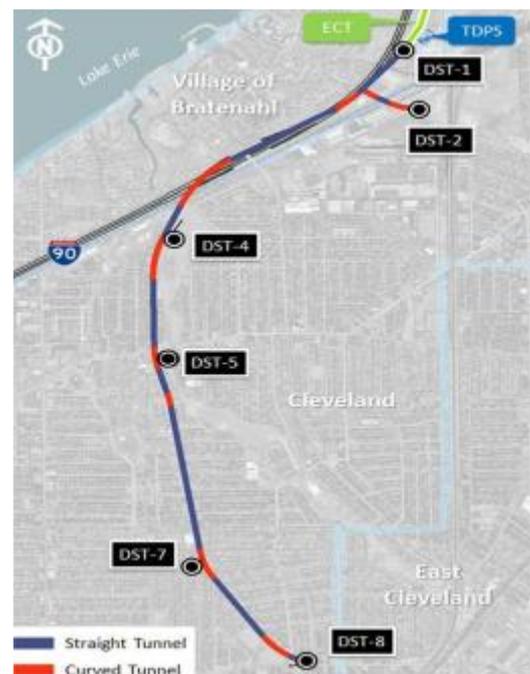
Figure 1. Project overview

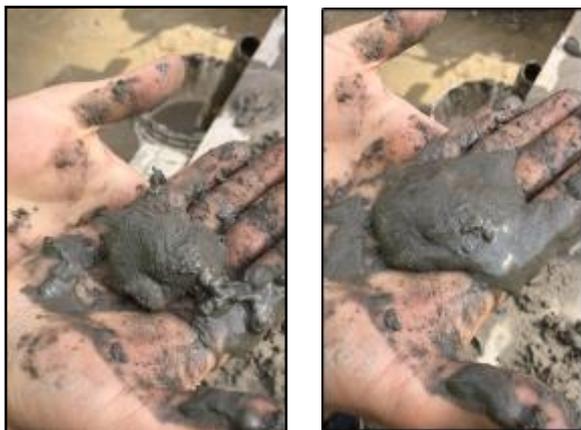
Figure 3. Silty dilatant material behavior Class C soil
a) before shaking b) after shaking

This class of material has been subject matter for discussion due to its properties. In fact, a portion of the Class C soil is *Rock Flour silt*, also known as *Bull's Liver*. (fig.3) Because of its smooth texture, this inorganic silt is often mistaken for clay, but may be readily distinguished from clay without laboratory testing. *Rock flour* silt when shaken in the palm of the hand expels water with a dilatant behavior associated. This particular type of inorganic silty soil is the most unstable soil of his category (Terzaghi et all, 1967).

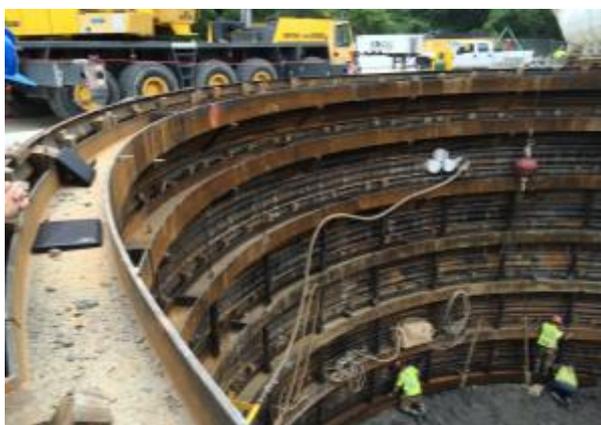
Figure 4. DST-1 Tiers

The DST-1 temporary earth retention system in soft ground is generally designed as a 14.6 m diameter 7 gauge 2-flange steel liner plate with internal W12x72 ribs at 1.3 m spacing. The system is designed so the steel ribs carry the fully soil and hydrostatic loading in compression and the liner plates act as lagging members carrying the load to the steel ribs. Wood blocking is placed between the plates and ribs at approximately 0.5 m to transfer load between the plates and ribs.

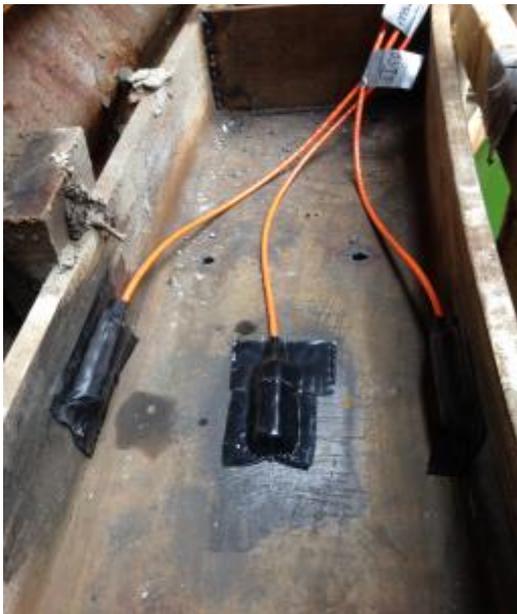
Figure 10. Strain Gage Placement

Spot welded strain gauges were installed on several of the steel ribs in the excavation. However, since the shaft had been flooded and the shaft could not be dewatered until the ground freezing had become effective, only the steel rib at Elevation 176.5 m (Rib 8) was accessible in the early stages of the ground freezing operation. The strain gauges were installed on May 27, 2016 which was approximately three days after the ground freezing was commenced. The gauges were installed on two opposite locations (stations) and consisted of a set of three gauges at each station. The gauges were installed in a horizontal direction with one gauge on the web face of the internal (shaft) side flange, one gauge across the top web, and one gauge on the web face of the external (soil) side flange.
